RJM Enterprises

Confidential - Property Inspection Report - Confidential

123 Main, Santa Rosa CA, 95400 Inspection prepared for: Mr Smith & Mrs Smith Agent: Ms Jones - Sell it Realty

Inspection Date: 1/14/2011 Time: 9:30 AM Age: 32 Size: 1899 sq.ft. Weather: cloudy

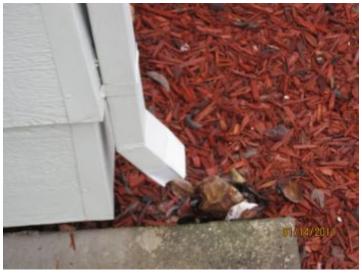
- The roof drainage system appeared in serviceable condition, at time of inspection.
- Not all gutters protected from debris with a gutter cover product.
- Downspouts which discharge onto the ground above grade should discharge a good distance away from the house -- four (4) to six (6) feet or more, if possible. The slope of the ground in this area should be away from the house to direct water away from the foundation. See illustration. Location:

divert water away from foundation

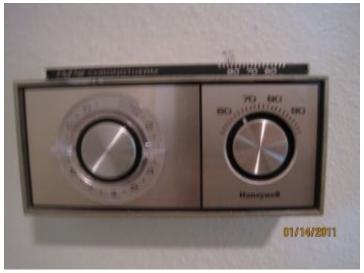
- No deficiencies noted.
- Thermostats are not checked for calibration or timed functions.
- IMPROVE: Non-programmable thermostats have no energy saving capabilities as do digital setback-type thermostats. Recommend an upgrade to a modern, digital programmable thermostat. This could yield a saving of up to \$180 per year in energy costs.

recommend upgrading thermostat

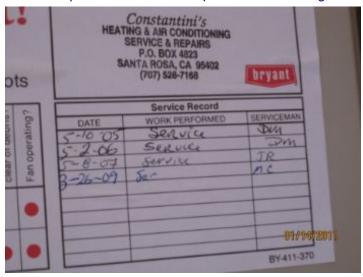
Description: Forced air natural gas furnace - located in laundry room closet • Bryant Age and Heating Capacity: 18 • Approx 80,000 BTU capacity Observations:

- No deficiencies observed.
- Annual/Seasonal professional HVAC inspection and cleaning service contract is recommended.

last service 3/26/09

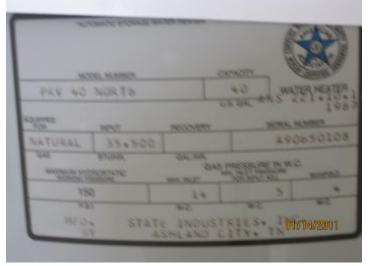
Age: Older than 20 years • FYI: Water heaters have a typical life expectancy of 8-12 years. Observations:

- A Temperature Pressure Relief (TPR) valve present. This safety valve releases water (and thus relieves pressure) if either the temp or pressure in the tank gets too high. The TPR valve discharge tube must be made of copper, iron, or CPVC (NOT regular PVC). It must terminate within 6" above the floor--the end cannot be threaded or have a fitting.
- Water heater is past the end of its typical service life. Highly recommend replacement.

water heater reaching end of life span (1987)

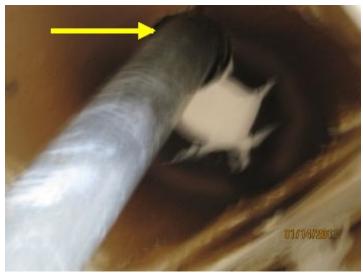
- Minimum water heater double-wall vent pipe clearance from combustible material is 1".
- SAFETY CONCERN: Gas burning water heater vent pipe has less than required minimum distance from combustible materials. This is a fire hazard. Licensed contractor repair as needed.

vent pipe clearance around combustible materials should be a least 1 inch

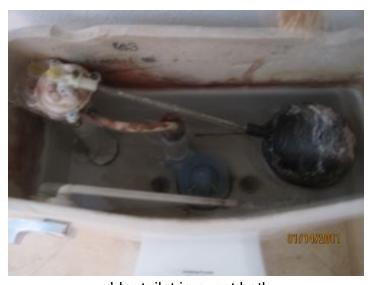
Operated when tested. Appeared functional, at time of inspection - except as noted. NOTE:
 Older toilet in guest bath. Internal components in tank are reaching the end of their useful service life.

older toilet in guest bath

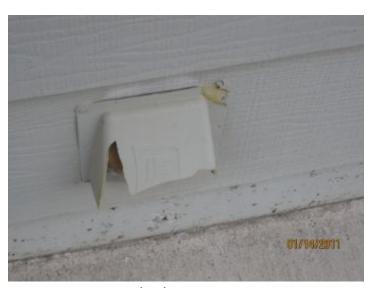
10. Dryer Vent				
	Observations: • Damaged exterior vent cover. • Properly vented to exterior.

broken cover
